## NBS TECHNICAL NOTE 1109

Characterization of Electrical Ignition Sources Within Television Receivers

George J. Rogers

David D. Evans

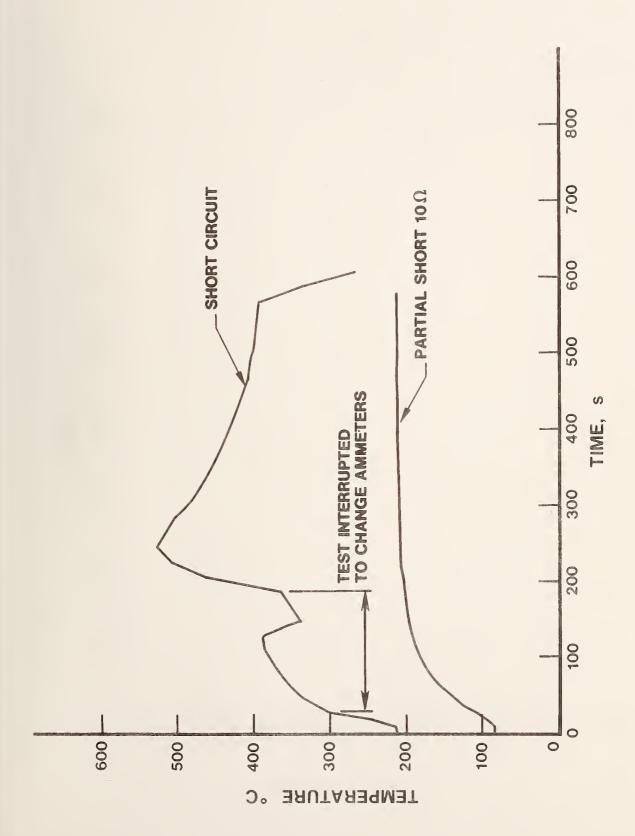
Figure 10. Tests 4 and 10, 48.3-cm black and white, temperature of resistor R14

The short circuit increased the load on the supply to 520 mA and increased the dissipation in R14 to about 16 watts. In test 4, the temperature of R14 climbed to 560°C in 3 minutes and had stabilized at about 570°C when the test was terminated after 5 minutes (fig. 10). In test 10, the temperature climbed at about the same rate to 475°C after 1 minute 20 seconds, and thereafter decreased. At the same time resistor R14 was observed to move slightly, probably indicating that the heat conducted through the leads had loosened the solder holding the resistor to the printed circuit board. The drop in the temperature of the resistor following this occurrence probably indicates that the resistance had begun to change at this point.

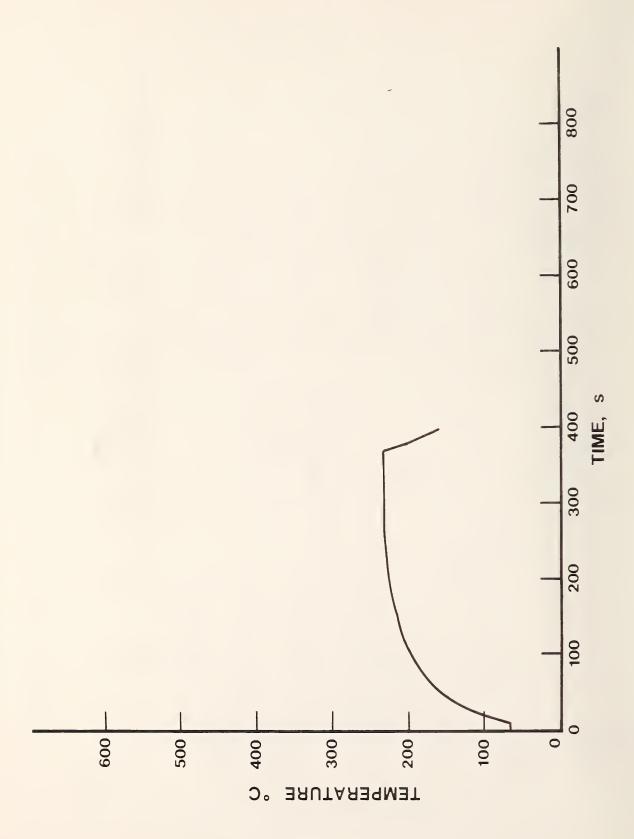
Figure 17. Test 15, 48.3-cm color, temperature of resistor R23

Within 30 seconds, however, the temperature of the decoupling resistor in the 27-volt supply to the sound module, R23, had reached a peak of  $470^{\circ}\text{C}$  before dropping to  $260^{\circ}\text{C}$  at the conclusion of the test (fig. 17). At the same time the resistance of R23 increased tenfold, so that it had to be replaced after the test. Temperature increase in other components was less than  $10^{\circ}\text{C}$ .

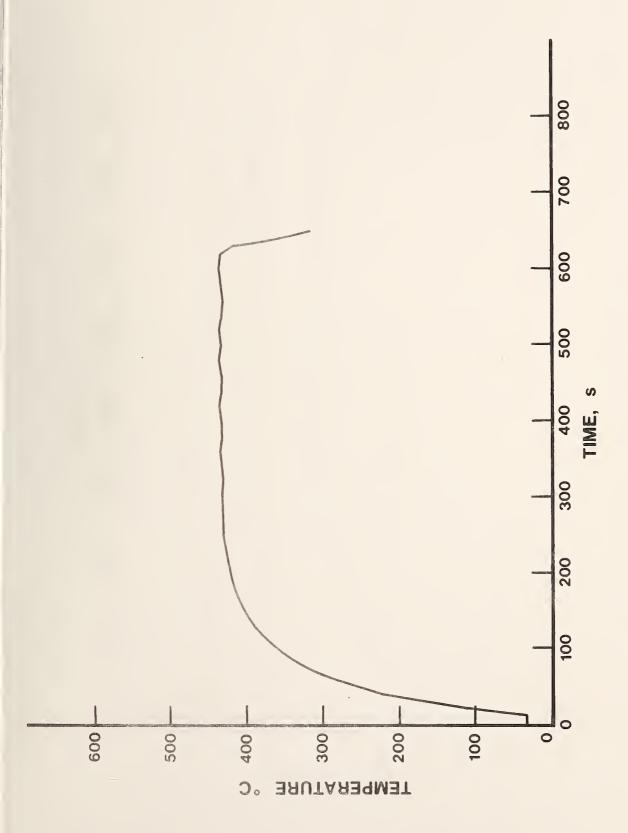
Test 25, 63.5-cm color, temperature of resistor R32 Figure 25.

The decoupling resistor in the 26-volt supply (R32, fig. 22) was further stressed by adding an extra 10-ohm load to the output of the supply (point A, fig. 22). Such an overload could be caused by a defect in the audio output module or a partial short circuit in the cabling connecting the module and the power supply. The 550 mA increase in current caused a 2-volt reduction in the output voltages of the 26 and 23-volt supplies and increased the current through the 1-ampere fuse to 0.9 ampere. Power dissipated in R32 increased to more than 13 watts causing an increase in its temperature to 435°C after about 5 minutes (fig. 25). The reduction in the output of the 23-volt supply

When the short circuit was removed after 10 minutes, operation of the set returned to normal. There was no visible damage to resistor R42, the transformer wires, or other components near R32.

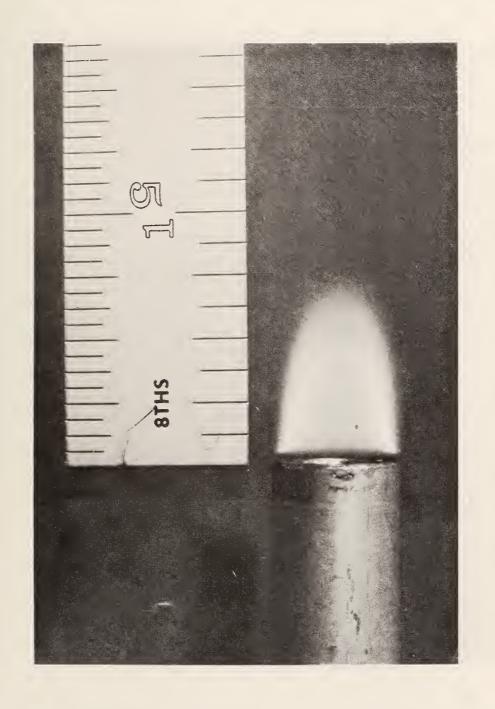
48.3-cm black and white receiver, sealed for reduced ventilation test Figure 28.

Experimentally, the operating temperatures of selected components were measured under normal conditions and with all ventilation openings in the cabinet sealed with 0.3-mm thick duct tape (fig. 28). The data are summarized and tabulated in tables 2 and 3. The temperature increase caused by restricted ventilation was higher in the smaller, more compact sets, but in all cases was less than 20°C. It should be noted that although the cabinet openings were sealed in the blocked ventilation tests, circulation of air around the cabinets themselves was not restricted. Air flow about the receiver may have been enhanced by the ventilation of the hood under which all tests were performed.
